# Quality Matters

This is the ninth in a series of technical notes covering aspects of glassfibre reinforced concrete (GRC) technology.

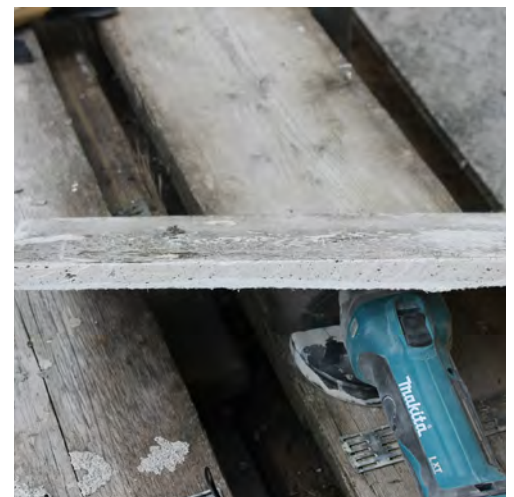
**Figure 2**

GRC architectural dressings and claddings were specified for use on a large retail/office development constructed in 2007. Within two years of completion the GRC was suffering from excessive weathering and cracking across all elevations. Various consulting bodies were employed to determine the cause of the failures with the consensus being various contributory factors were causing continuing and progressive failure.

These factors included, elements being manufacture too thin, flexural strengths not attaining design requirements, incorrect installation and the use of non-corrosion resistant fixings. As a result the GRC was unable to resist the various forces and loads imposed on it and duly failed in service.

**example of incorrect thickness of face coat and GRC structural backing**

The result of all the above was a building which was covered in scaffolding and netting for some five years while investigative and legal processes were progressing. Ultimately all the GRC units were removed and replaced with high quality GRC in 2014 at substantial cost to the building owner.

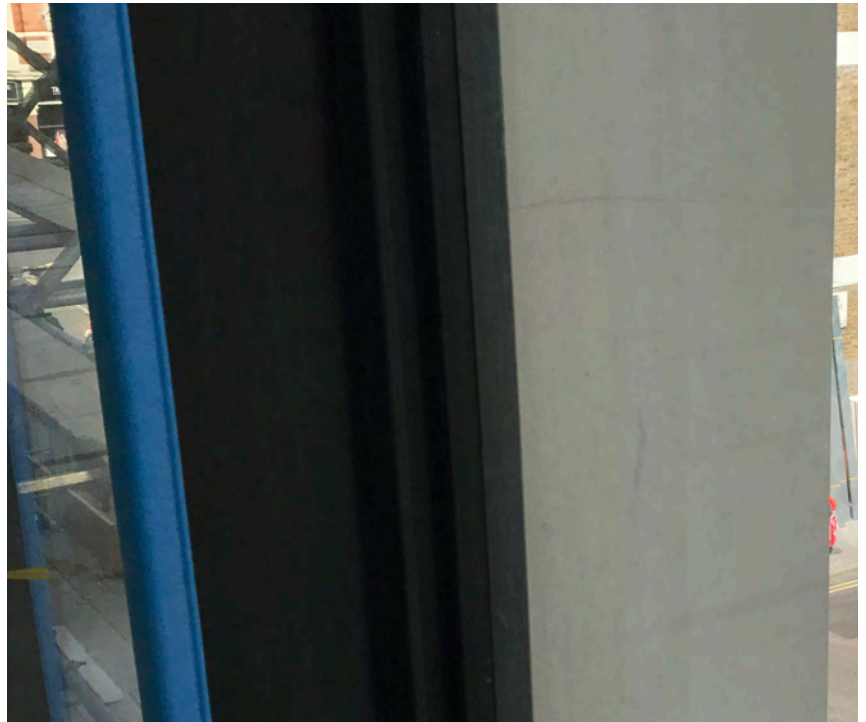
This project is a high profile office development located in a major European city constructed in 2017. Even before completion the client noted excessive cracking to vertical GRC fins fitted to the external façade by the specialist sub-contractor.

Investigation showed that the fins had been manufactured using a mix design which fell outside the recommendations of the GRCA Specification. As a result the main contractor commissioned a series of flexural bending tests to be carried out on samples taken from finished products. These tests showed the fins flexural strength differed considerably between test coupons.

It was ultimately concluded that the method of production differed considerably from the method of producing the required weekly test samples. As a result actual material strength in the finished product was lower than those used in the design calculations.

**Figure 3**  
**Example of cracked fins**

At the time of this publication it is likely all the fins will require replacement resulting in a significant practical completion of the building.

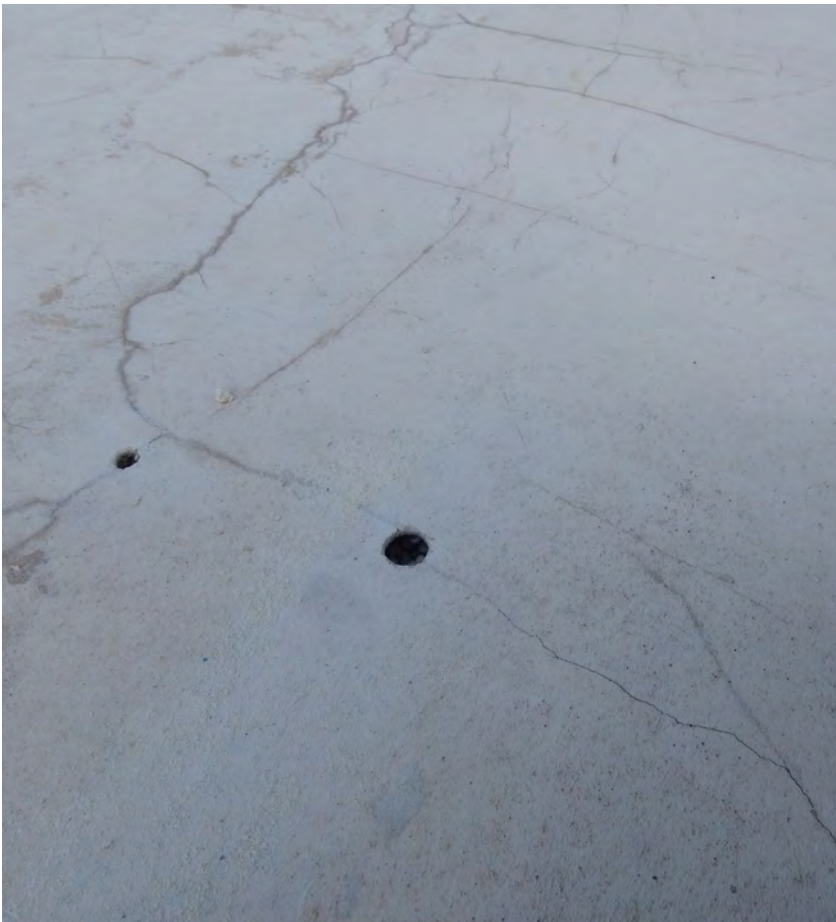
A unique and inspirational design at a European University Campus built in 2015 featured extensive use of complex geometry GRC cladding panels. Within 12 months of completion cracking began to appear across some 25% of the GRC units.

Specialist investigation revealed good manufacturing practices had been completely ignored by the manufacturer. The thickness of the GRC was found to be up to 10mm below that required in the design calculations. Manufacture had used split mould casting techniques which were not competently executed resulting structural delamination. In addition it was found that bright zinc plated cast in threaded anchors had been cast into the units to act as primary fixing points. These had already begun to significantly corrode.

**Figure 4**  
**Example of incorrect thickness resulting in failure**

Ultimately all the GRC is likely to be removed with monthly safety inspections being carried out until this can be practically completed.

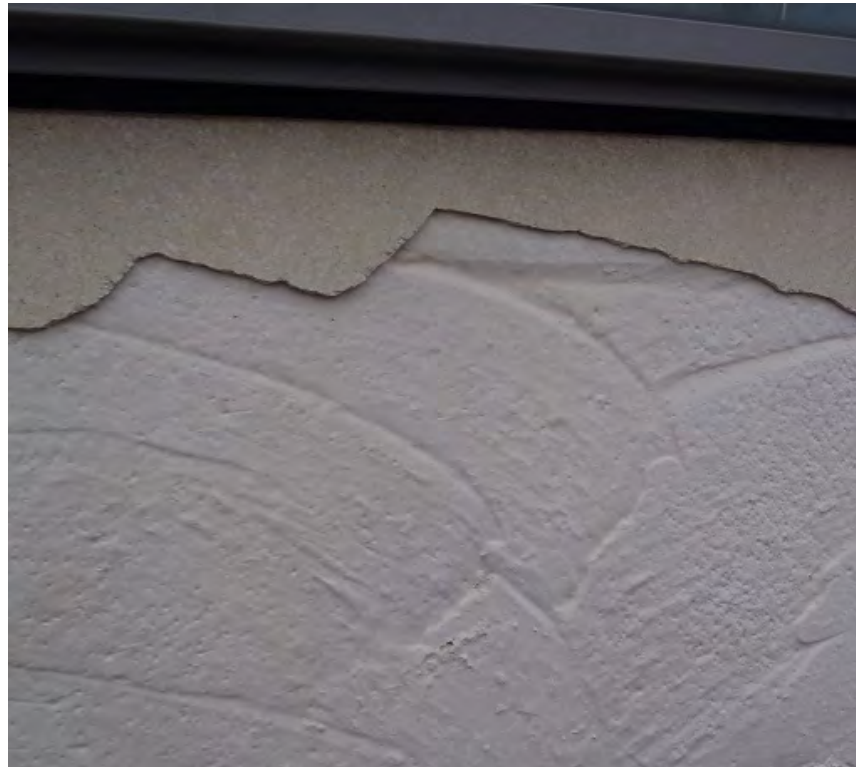
Within the main contractors defects liability period cracks and delamination of the face coat began to appear. Specialist reports and testing were commissioned which concluded that not only was the GRC not of sufficient structural strength at the ultimate failure load but the face/mist coat had been allowed to dry out prior to application of the backing GRC structural coat.

**Figure 5**  
Example of face coat delamination

The only course of action open was removal and replacement of all GRC panels to ensure the public's safety. The cost, inconvenience and reputational damage are of course considerable.

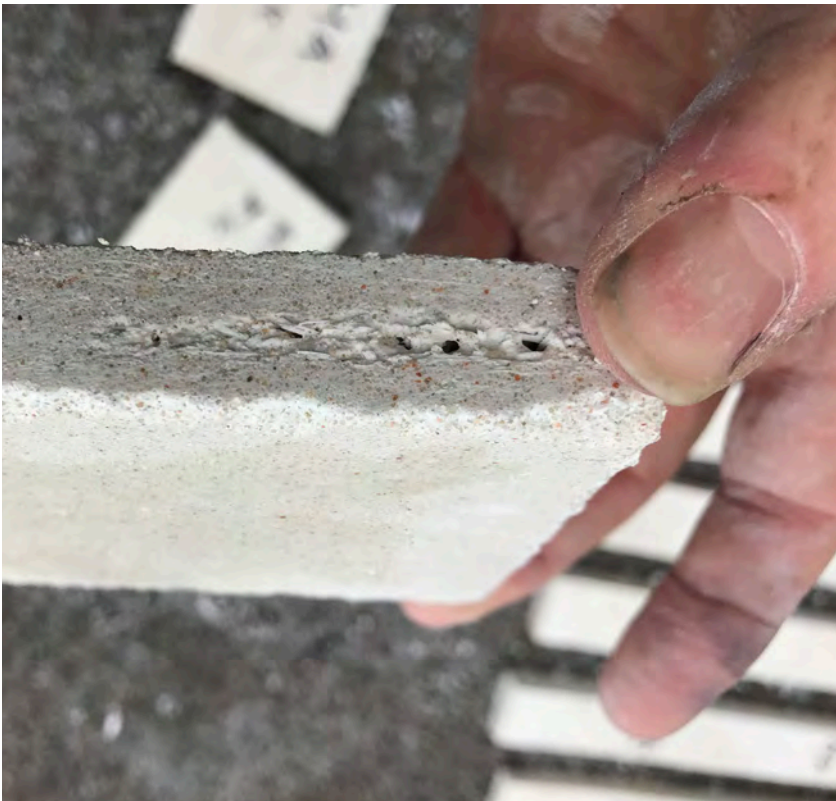
Prior to installation of several thousand square meters of GRC cladding the facade sub-contractor, becoming concerned, appointed a specialist GRC consultants to visit the manufacturer and ensure correct manufacturing methods were being employed. This inspection revealed significant failings in the manufacturing process control.

Subsequent full sized product testing revealed significant failures and the GRC panels being rejected as not specification compliant. Replacement panels were manufactured with suitable corrective actions including a robust ITP, and regular supervision by external quality control specialist consultants.

**Figure 6**  
Example of badly compacted GRC
