# Quality Matters

This is the ninth in a series of technical notes covering aspects of glassfibre reinforced concrete (GRC) technology.

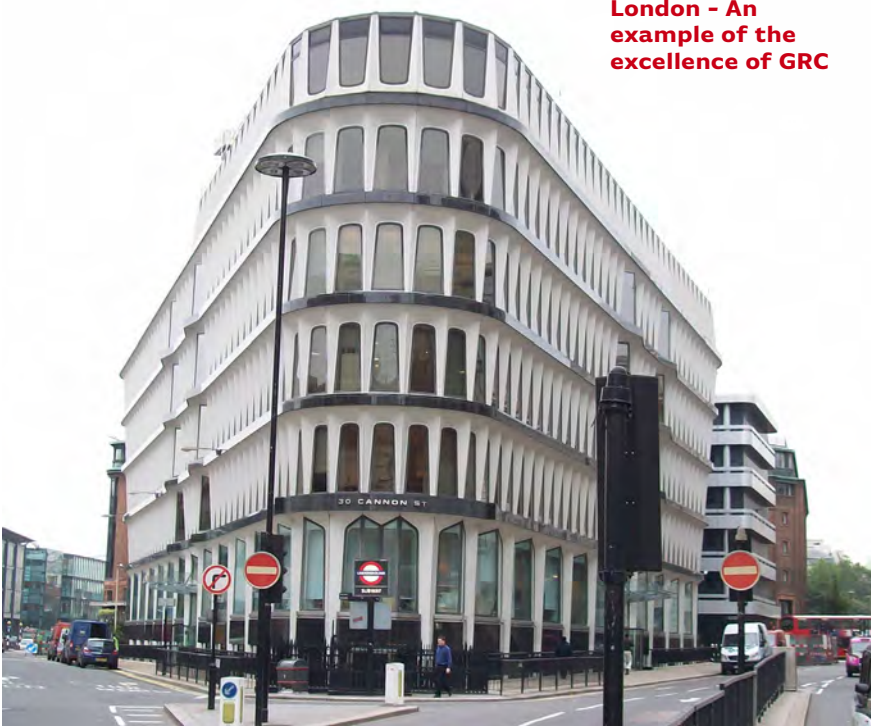
Figure 1

30 Cannon Street, London - An example of the excellence of GRC

If all the correct processes are employed GRC is a highly robust material which will perform beyond expectation. An example of this is 30 Cannon Street, London (Figure 1) which features in many GRC publications. The unique GRC facade cladding on the building has already performed for over 40 years and a recent in-depth examination has shown that the components should last at least another 40 years. The building continues to provide credible performance evidence of the durability of correctly manufactured GRC.
